# Non-surgical root canal retreatment: a case report of eleven silver cones removal in maxillary first premolar

## Abstract

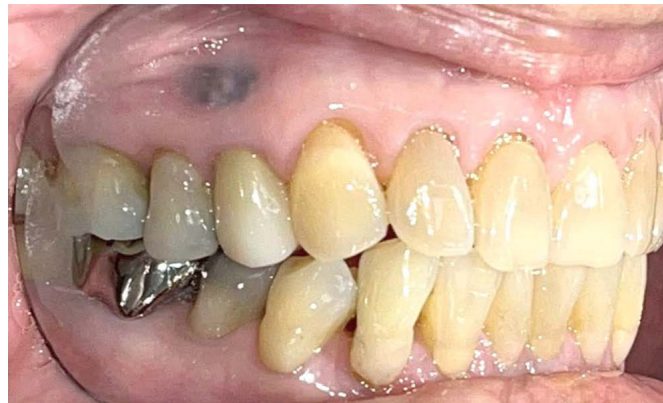
Extraoral examination showed no facial swelling or asymmetry, and mandibular opening was adequate. Intraoral examination revealed an open margin porcelain-fused-to-metal crown on the buccal aspect, without signs of traumatic occlusion in either centric or eccentric occlusal positions. The sinus tract opening was visibly located at the buccal gingiva, aligned with the root apex of tooth 14, and a localized area of black pigmentation was noted in the surrounding gingiva, suggestive of local argyrosis (Figure 1). Notably, the tooth exhibited negative responses to percussion and palpation, with no mobility or soft tissue swelling present. Periodontal probing depths ranged from 2-3 mm around the tooth, and pulpal sensibility tests were not conducted as the tooth was endodontically treated.

**Figure 1** Sinus tract opening at the buccal gingiva, aligned with the root apex of tooth 14, and a localized area of black pigmentation was noted in the surrounding gingiva, suggestive of local argyrosis.

Notably, an area of local argyrosis was still observed at the previous sinus tract opening site. This area was inconspicuous during smiling and was not deemed aesthetically concerning by the patient. Periodontal probing depths were recorded within normal limits, ranging from 2-3 mm around the tooth.

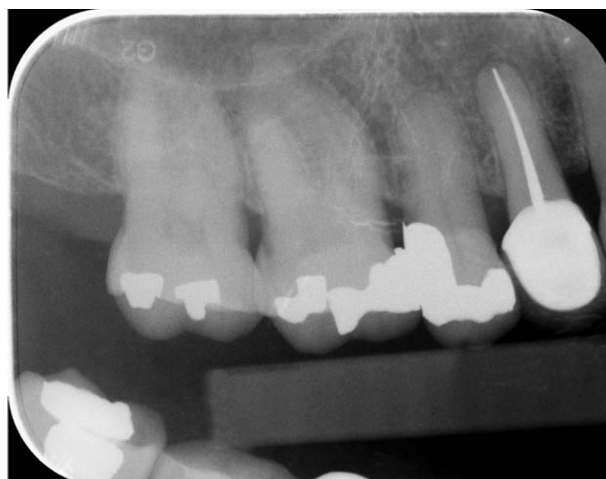
Pre-operative periapical radiographs revealed a metallic radiopacity covering the crown, consistent with the intraoral findings of the porcelain-fused-to-metal crown. Within the root canals, a streak of homogeneous metallic radiopacity were observed, extending from the coronal aspect to the apex. This suggested the presence of silver cones utilized as root canal filling materials. A horizontally angulated radiograph further illustrated multiple streaks of

**Figure 2** Pre-operative radiograph. A metallic radiopacity around the crown, indicating a porcelain-fused-to-metal crown. A consistent streak of metallic radiopacity is also observed within the root canals, extending from the crown to the apex, suggesting the presence of silver cones used for root canal filling. The alveolar bone crest level was within normal limits.

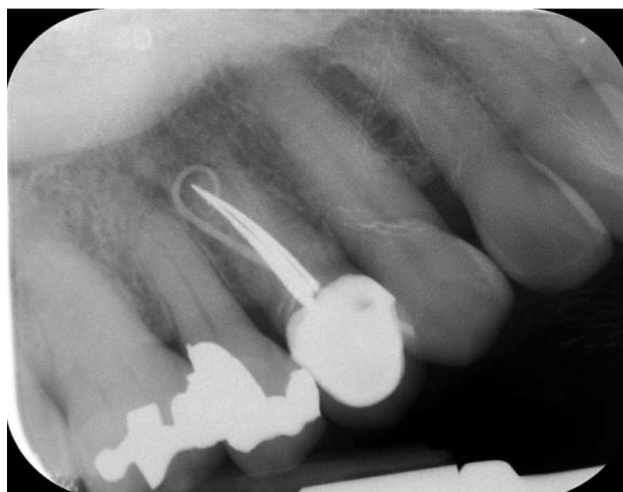
metallic radiopacity, further supporting the suspicion of multiple silver cones, likely placed using a lateral condensation technique. Gutta-percha tracing confirmed that the tract extended to the apex of tooth 14, with an associated periapical radiolucency at apical third of the root, measuring approximately 1x3 mm in size. The alveolar bone crest level was within normal limits, indicating that the surrounding bone structure was preserved (Figure 2 and Figure 3).

**Figure 3** Pre-operative radiograph with horizontally angulated, and gutta-percha tracing. The presence of multiple streaks of metallic radiopacity reinforces the suspicion of several silver cones, likely obturated through a lateral condensation technique. Gutta-percha tracing indicated that the tip terminated at the apex of tooth 14, accompanied by a periapical radiolucency at the apex measuring approximately 1x3 mm in size.

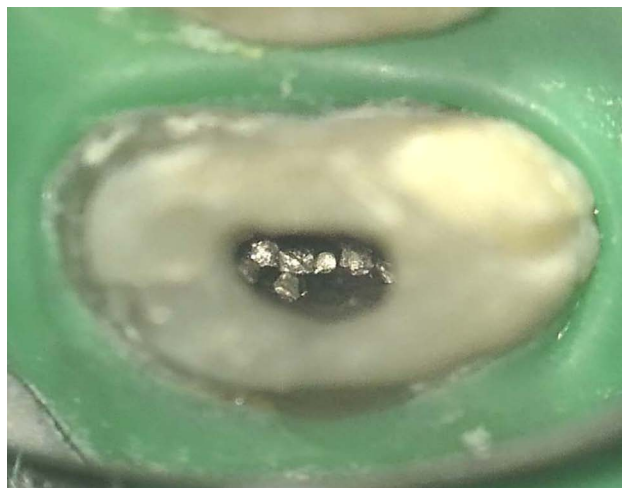
Under the dental operating microscope, seven silver cones were initially identified within the canal (Figure 4), with little evidence of the surrounding root canal cement discernible. A bypassing technique was employed utilizing small K-files (ISO sizes 10 and 15), which were maneuvered adjacent to the silver cones to create lateral or circumferential space around each cone. This procedural step is vital for accommodating multiple file placements during subsequent removal attempts.

**Figure 4** Following rubber dam isolation and the removal of the composite core, seven silver cones were observed within the canal under a dental operating microscope, accompanied by minimal evidence of surrounding root canal cement. This finding supported the hypothesis that the tooth had been previously obturated using laterally condensed silver cones.

Initial bypassing was achieved to a depth of approximately 12-13 mm from the occlusal surface, with the provisional length of the root canal estimated at 15-16 mm. The retrieval of five silver cones was conducted sequentially. Some cones could be retrieved using only a single Hedström file, while others necessitated the application of a braiding technique. In this technique, multiple Hedström files were simultaneously inserted into the canal, arranged circumferentially around the bypassed. The files were then twisted to create a tight interlocking grip around the cone prior to removal.

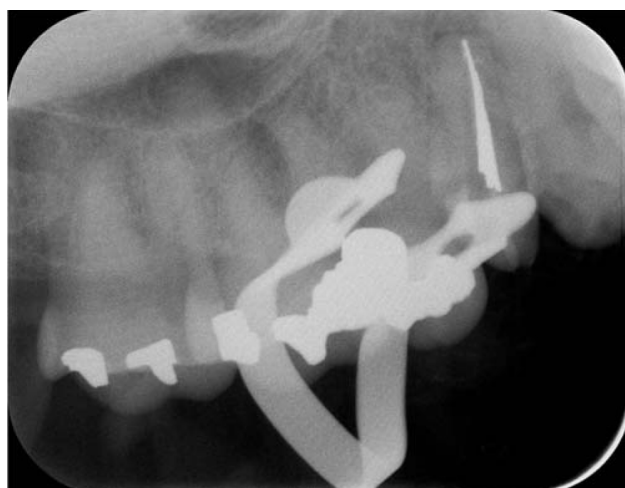
After the removal of five silver cones, a canal septum separating the two canals within the tooth became visible, confirming that the palatal canal had been successfully cleared. A distally angulated periapical radiograph was subsequently obtained to confirm the presence of any remaining silver cones within the buccal canal (Figure 5).

**Figure 5** Following the removal of six silver cones from the palatal canal, a periapical radiograph angled distally was obtained to verify the presence of additional silver cones still situated within the buccal canal that had not yet been retrieved.

The remaining silver cones within the buccal canal were subsequently retrieved utilizing either

a single engagement of a Hedström file or in conjunction with a braiding technique. The silver cone located furthest buccally was the first to be mobilized, suggesting it may have been the last cone placed during the prior obturation. This cone was not obstructed by any other cones. Following the removal of this cone, six additional silver cones were successfully retrieved from the buccal canal. In total, eleven silver cones were removed from the premolar tooth without any fragmentation or separation, as shown in Figure 6.

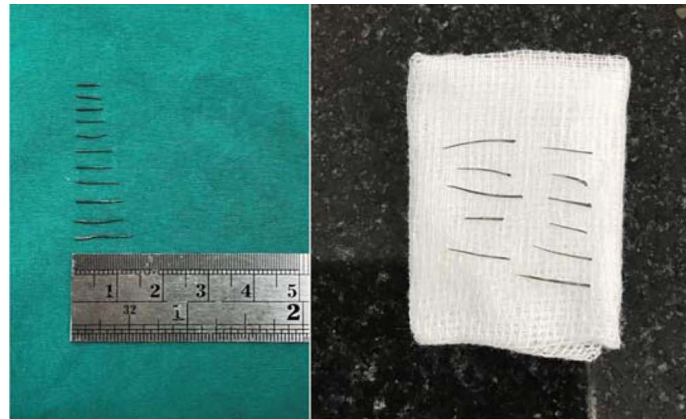
**Figure 6** By carefully bypassing around the cone to ensure adequate surrounding space, followed by the utilization of Hedström files alongside a braiding technique, a total of eleven silver cones were successfully retrieved from both canals without any fragmentation or separation.

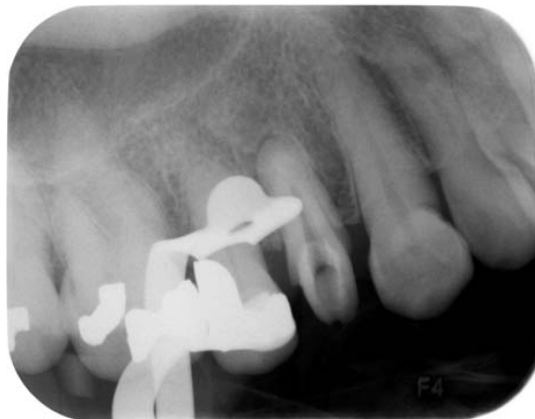
**Figure 7** A periapical radiograph taken to ensure complete removal of all silver cones without any fragmentation or separation.

A periapical radiograph was obtained to confirm the complete removal of all cones (Figure 7). The working lengths of both canals were then assessed (Figure 8). Mechanical instrumentation of the canals was performed using rotary instruments, targeting a master apical size of 40 for both canals. Throughout these procedures, a 2.5% sodium hypochlorite solution was utilized, supplemented by passive ultrasonic irrigation. For intracanal medication, an injectable premixed calcium hydroxide paste was employed.

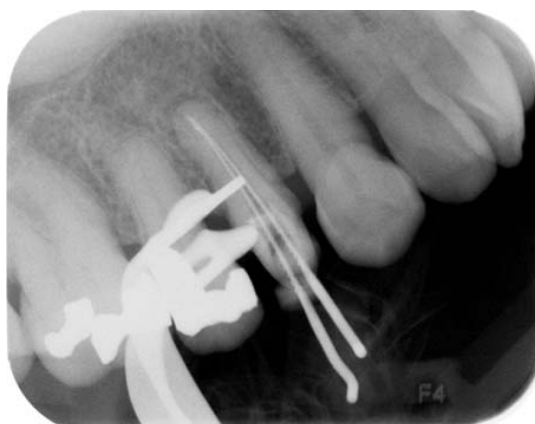
**Figure 8** A periapical radiograph illustrates the determination of working length of tooth 14. Two canal orifices were identified, separated by a septum; however, the apical portions of both canals converged, as indicated by the configuration of the files.

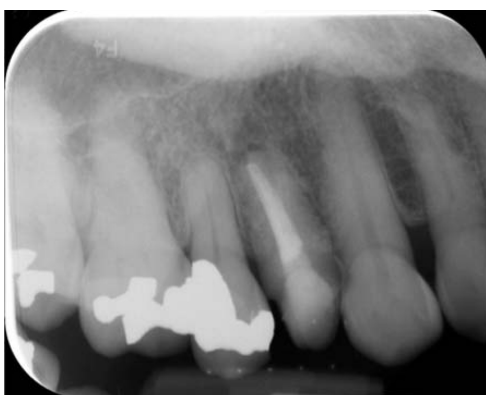
**Figure 9** A periapical radiograph taken after complete root canal obturation.

aspect had resolved, and the patient reported no symptoms. Following the selection of the main gutta-percha cones, the canals were irrigated with a 17% EDTA solution, followed by 2.5% sodium hypochlorite. The canals were then dried using paper points, and root canal obturation was completed with a resin-based root canal sealer employing the lateral condensation technique (Figure 9). In subsequent appointments, prefabricated posts were cemented in both canals using Multicore Flow, and a new zirconia crown was delivered to the patient as the final restoration.

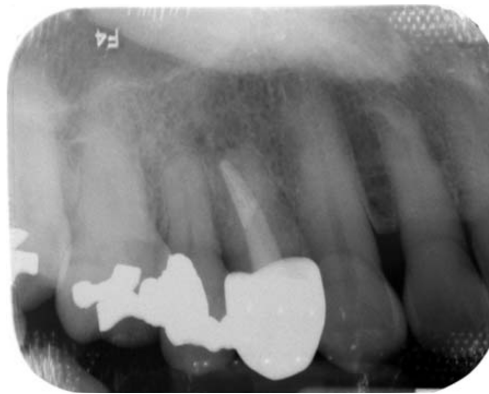
Radiographic assessment indicated an area of widened periodontal ligament space at the apical segment of tooth 14. Additionally, there was an increased visibility of the lamina dura compared to pre-operative radiographs (Figure 10). These observations suggest ongoing, yet incomplete periapical healing of the tooth. The patient has been scheduled for a subsequent evaluation in one year, marking the two-year follow-up post-treatment completion.

**Figure 10** The one-year post-operative follow-up radiograph reveals evidence of ongoing, though incomplete periapical healing. Notably, the apical portion of tooth 14 demonstrates a persistent area of widened periodontal ligament space, although this area has decreased in size. Furthermore, there is an observable enhancement in the visibility of the lamina dura at the apical segment of the root when compared to the pre-operative radiograph.
